Tests of Reinforced
Concrete Tee Beams

FLOYD SINNOCK HEWES
AND
CLARENCE AVISE HEWES

DEGREE OF BACHELOR OF SCIENCE

CIVIL ENGINEERING

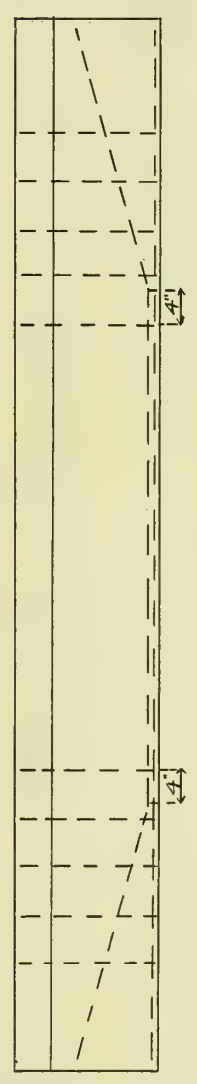
N^o 6 5- $\frac{3}{4}$ in. Round bars. 8-10" x 3 $\frac{1}{2}$ ", 2-10" x 6 $\frac{3}{4}$ " stirrups.

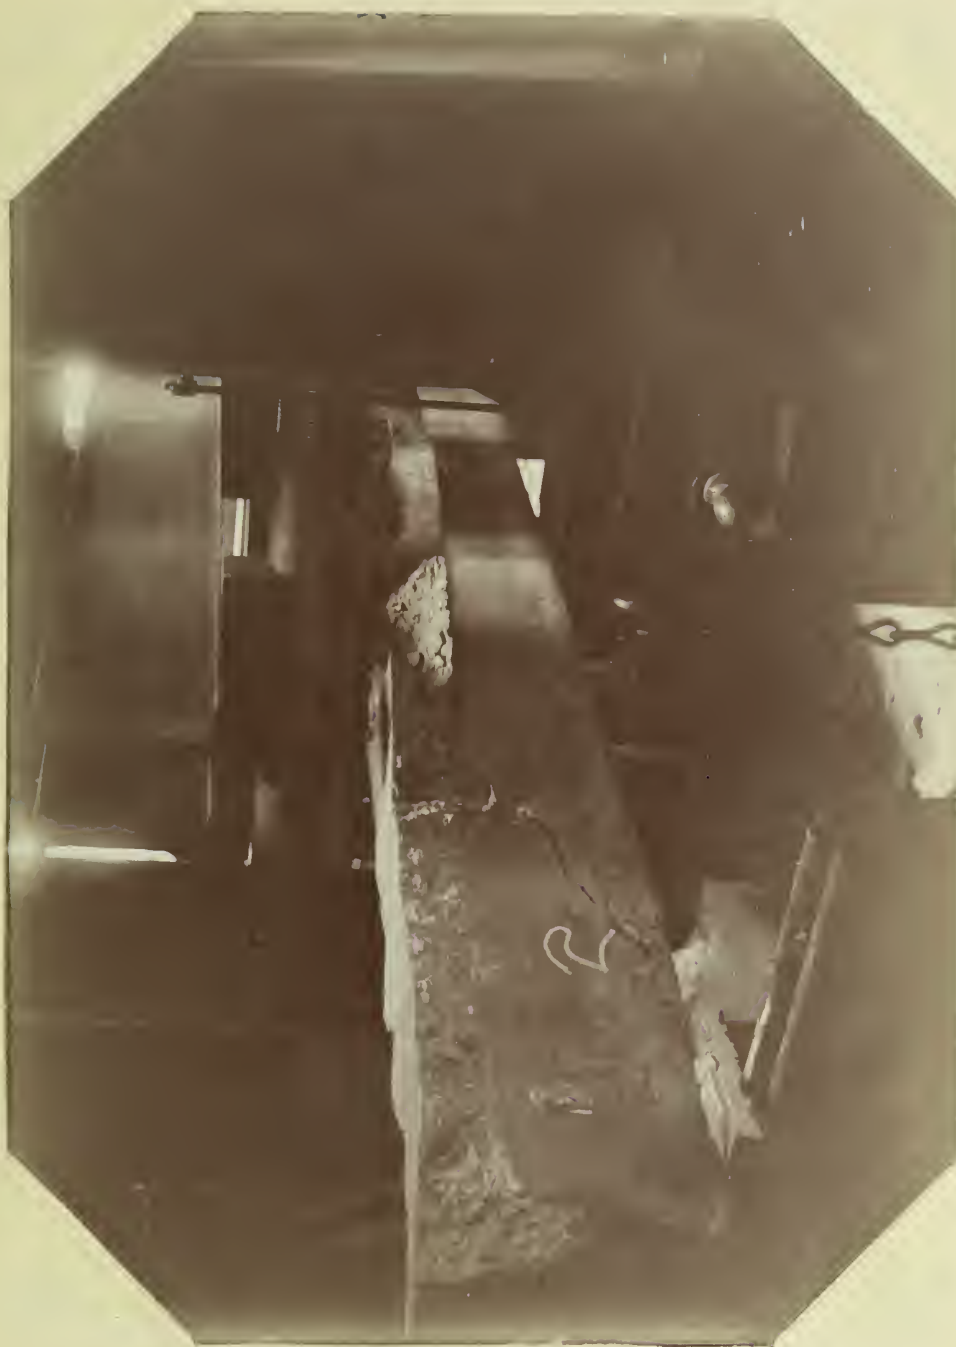
BEAM N^o 2 IN PLACE
AFTER TESTING
SHOWING SHEARING OFF OF FLANGE.
EAST END.

Beams no. 2, 5, and 9 were all 32 in. wide. Of these three, no. 2 was the only one that did not have reinforcement in the flange as shown on page 14. Of these three beams, this was the only one in which the flange was sheared off. In beam no. 5 a crack formed at about the maximum load along the junction of the web and flange but the flange did not drop off on account of the transverse reinforcement. In beam no. 9 no such cracks even formed. It seems from this that the small bars imbedded in the flange are advantageous.
